# Manhole Inspection Summary

Manhole # S29A\_\_102MH

Insp Date: **4/29/09 3:01 PM**

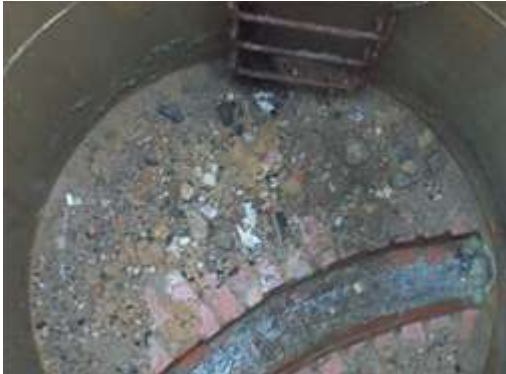
Defect 1

Condition: ☐ Sound ☐ Cracked ☐ Root Intrusion ☐ Deteriorated ☐ Leaks ☒ **Debris**

DEBRIS ON BENCH

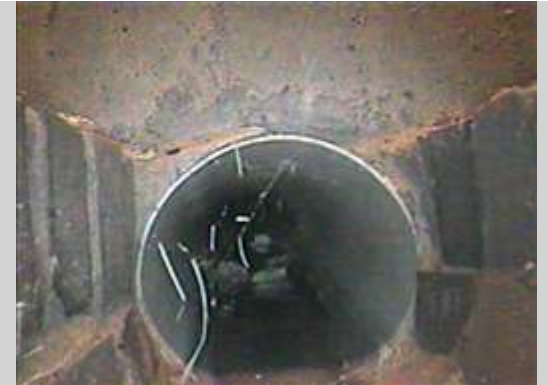
12 O'Clock Outflow

8 in. Circular Gravity Sewer  
Pipe Out @ 12 O'Clock

Pipe Material: **PVC** ☐ Pipe Lined

Invert Depth: **11.90** (ft.) Flow Characteristics: **None**

Deposits: ☒ None ☐ Mud ☐ Sludge ☐ Debris ☐ Grease

Infiltration: **None** Pipe Seal Cond: **Sound**

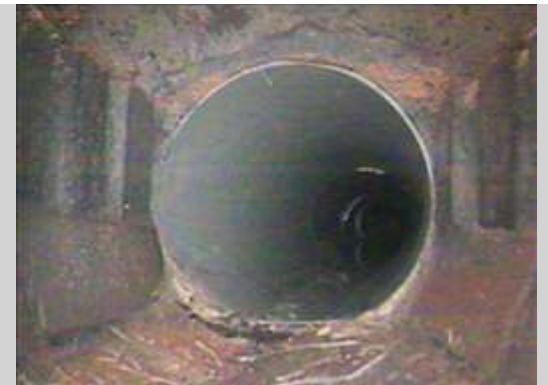
6 O'Clock Inflow

8 in. Circular Gravity Sewer  
Pipe In @ 6 O'Clock

Pipe Material: **PVC** ☐ Pipe Lined

Invert Depth: **12.20** (ft.) Flow Characteristics: **None**

Deposits: ☒ None ☐ Mud ☐ Sludge ☐ Debris ☐ Grease

Infiltration: **None** Pipe Seal Cond: **Sound**
